## ***TECHNICAL BULLETIN***

### ***ADDITIONAL WELDING ON FOOTRING OF CYLINDER***

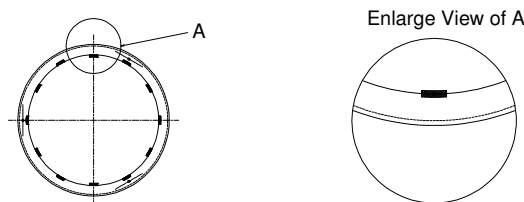
### **Welding Detail**

We have had two (2) cylinders returned to the Factory due to stress failure of welds on the footing.

Following an investigation, it was established that the retaining cylinder straps were found to be loose which allowed the cylinder to vibrate and move within the cylinder bracket.

- Each base ring must be welded with a min. of 12 welds.
- Welding place is six on the internal base ring, and six on the outside of the ring Staggered

Welds placement has been increased from six on the internal base ring and six on the outside of the base ring staggered evenly, this action commenced June 15, 2012.
